**Subject: Annual Inspection Report
Middleton Field Airport
Evergreen, Alabama**

ANNUAL INSPECTION REPORT

MIDDLETON FIELD AIRPORT

EVERGREEN, ALABAMA

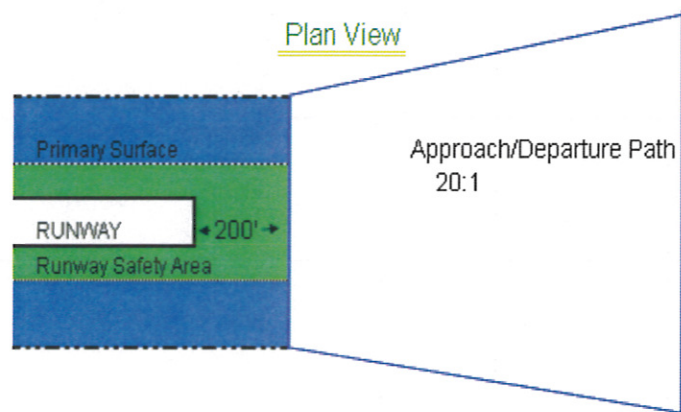
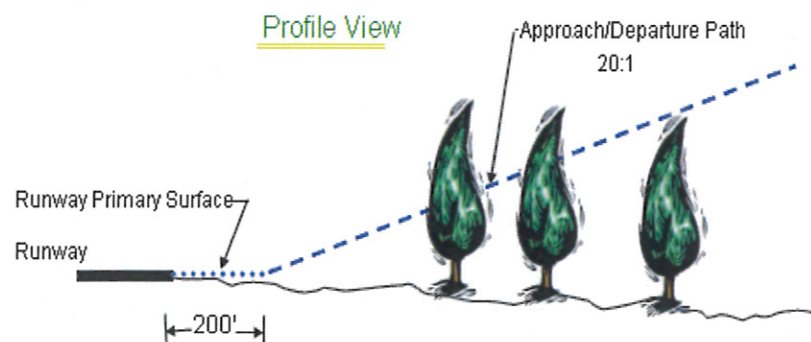
APPENDIX 1

Approach and Departure Path Dimensions			
Inner Width	Outer Width	Length	Acreage
250 Feet	450 Feet	1,000 Feet	8.04 Acres
Primary Surface Dimensions			
250 Feet Wide Centered Along Runway Centerline Extending 200 Feet Past the Runway End			
Runway Safety Area Dimensions			
120 Feet Wide Centered Along Runway Centerline Extending 200 Feet Past the Runway End
